Service Bulletin

Bulletin No.: PI1354A

Subject: Information on Vibration Analysis and Diagnostic

Models: 2014 Chevrolet Silverado 1500
2015 Chevrolet Silverado
2014 GMC Sierra 1500
2015 GMC Sierra

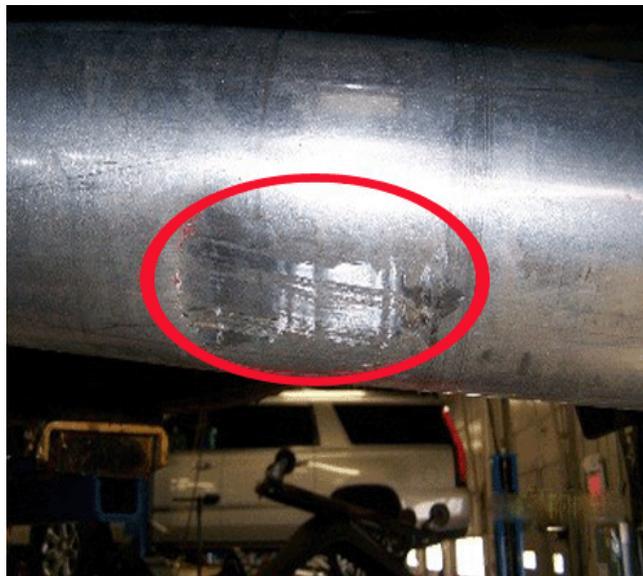
4002784

- Inspect the propeller shaft for dents or damage. There have been many cases of dented propeller shafts.
- For 4WD Trucks, remove the rear propeller shaft, seal output shaft and drive the vehicle in 4WD. If the vibration is gone, the rear prop shaft could be the problem.
- For vehicles with a 3:08 with a one-piece steel shaft, this can be replaced with a one-piece aluminum one that is utilized on all 3:42 and 3:73 ratios (K15543 and K15753 Models only).
- PIP5140: Low Speed Vibration 30-35 mph (48-56 km/h).
- Inspect the transmission output shaft bushing for irregular wear.
